DEPARTMENT OF TRANSPORTATION

Quality Assurance and Source Inspection

Contract #: 04-0120F4Cty: SF/ALA Rte: 80 PM: 13.2/13.9File #: 69.28**WELDING INSPECTION REPORT****Resident Engineer:** Pursell, Gary**Address:** 333 Burma Road**City:** Oakland, CA 94607**Report No:** WIR-009469**Date Inspected:** 28-Sep-2009**Project Name:** SAS Superstructure**OSM Arrival Time:** 1900**Prime Contractor:** American Bridge/Fluor Enterprises, a JV**OSM Departure Time:** 700**Contractor:** Zhenhua Port Machinery Company, Ltd (ZPMC), Changxing Island **Location:** Shanghai, China**CWI Name:** Li Ming, Lvli Qian**CWI Present:** Yes No**Inspected CWI report:** Yes No N/A**Rod Oven in Use:** Yes No N/A**Electrode to specification:** Yes No N/A**Weld Procedures Followed:** Yes No N/A**Qualified Welders:** Yes No N/A**Verified Joint Fit-up:** Yes No N/A**Approved Drawings:** Yes No N/A**Approved WPS:** Yes No N/A**Delayed / Cancelled:** Yes No N/A**Bridge No:** 34-0006**Component:** Tower/ OBG**Summary of Items Observed:**

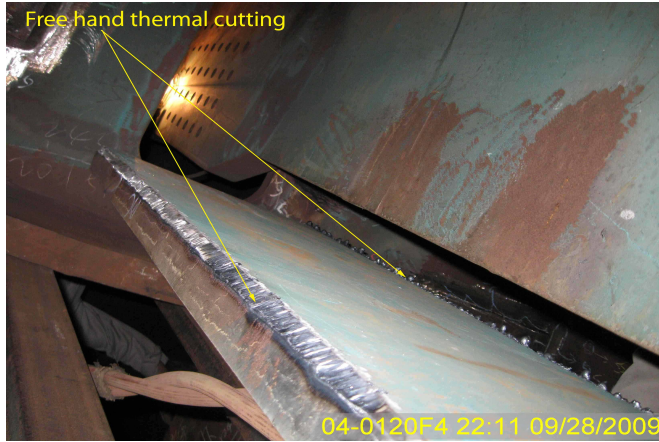
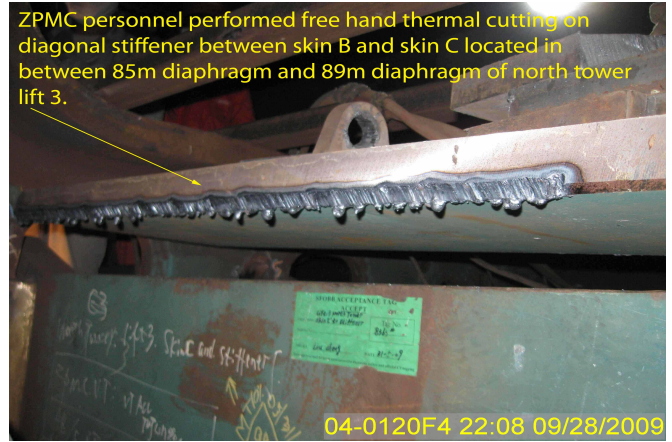
BAY #10

NORTH TOWER LIFT # 3

This Quality Assurance Inspector observed ZPMC personnel performed free hand thermal cutting on diagonal stiffener. The diagonal stiffener will be located between 85m diaphragm and 89m diaphragm at the skin B and C corner. The length of free hand cut was approximately 850mm. For additional information see attached photos.
